**DIAGNOSTIC AND FEASIBILITY STUDY
ASHMERE LAKE
Hinsdale, Massachusetts**

Prepared For: **Town of Hinsdale**
John A. Eagar
Lake Management Committee
P.O. Box 657
Hinsdale, Massachusetts 01235

Prepared By: **ESS Group, Inc.**
888 Worcester Street, Suite 240
Wellesley, Massachusetts 02482

Date: **May 31, 2003**

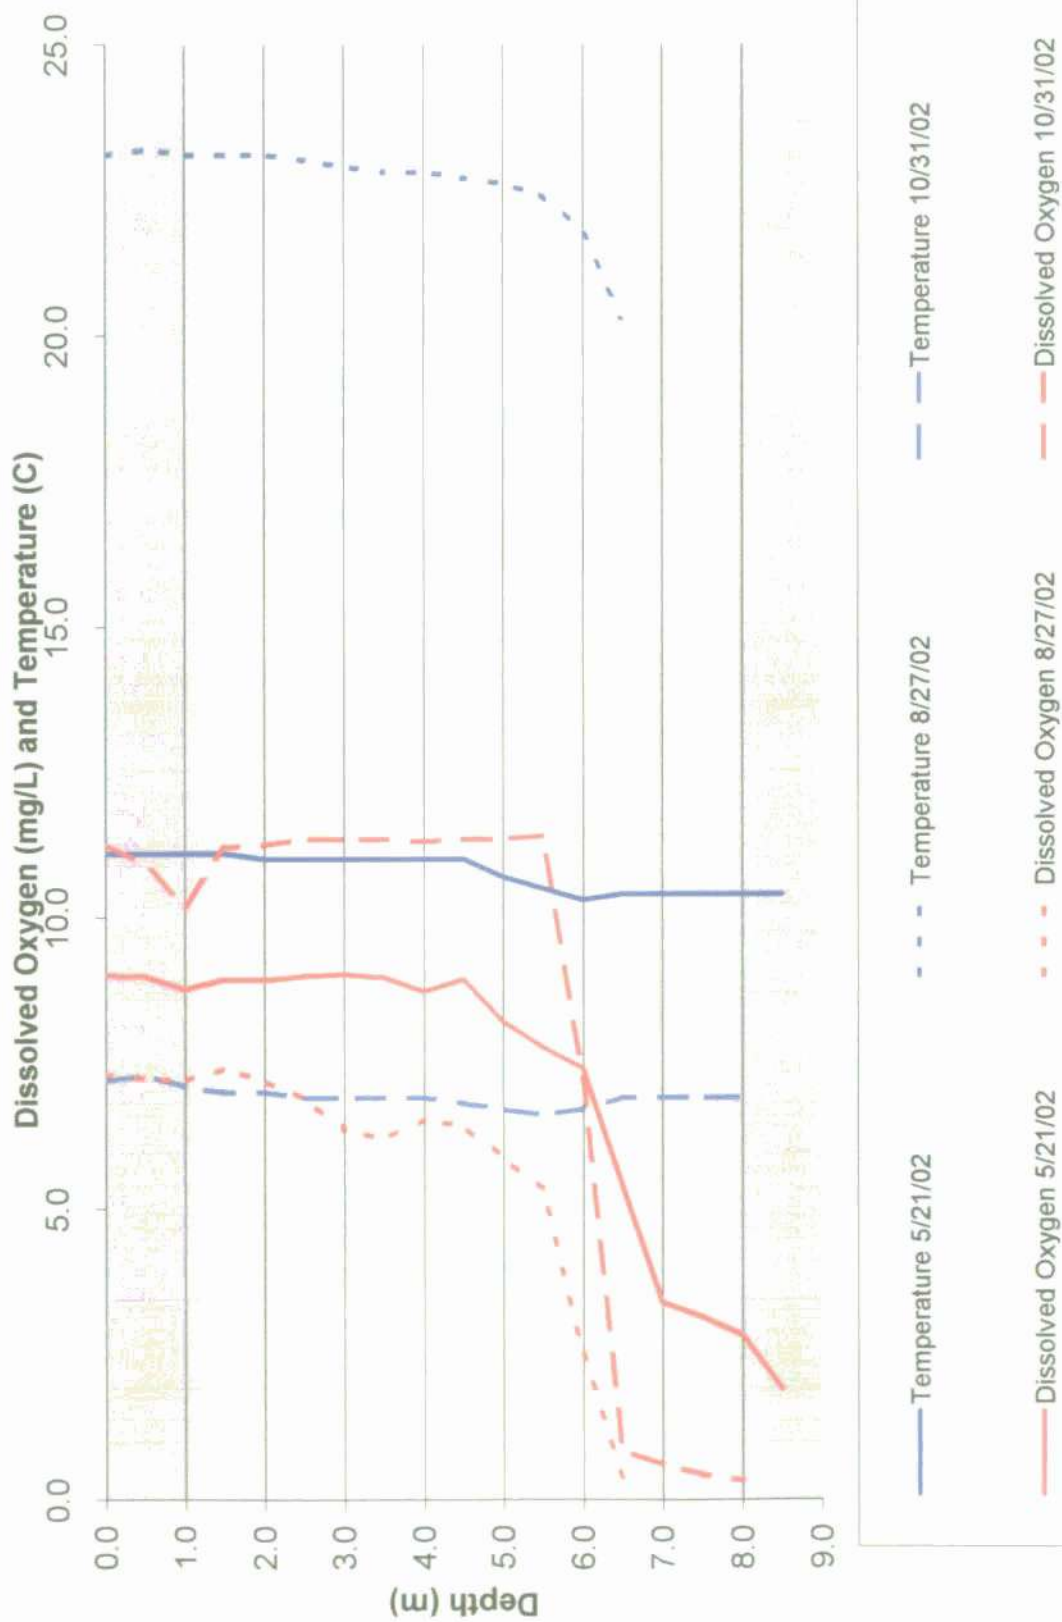
Figure 7. Temperature and Dissolved Oxygen Profile at Ashmere Lake, North Basin.

Water quality monitoring was conducted on three dry weather dates (defined as a minimum of 72 hours antecedent with less than 0.1 inch of rainfall). Monitoring occurred on May 21st, August 27th, and October 31st, 2002. Water quality was monitored at the tributaries on one dry weather date (August 27th, 2002) and one wet weather date (September 15th, 2002). Wet weather conditions were defined as a precipitation event of ≥ 0.25 inches, which was preceded by a minimum of 72 hours with less than 0.1 inch of rainfall. Water quality was monitored at the stormdrain, which discharges to the south basin of Ashmere Lake, on one wet weather date (September 15th, 2002). Water quality was monitored at the outlet on one dry weather date (August 27th, 2002). Results from the water quality monitoring program are summarized below for each parameter and presented in Tables 3, 4 and 5 and Figures 6 and 7.

Dissolved oxygen is the amount of molecular oxygen (O_2) dissolved in water. Dissolved oxygen below 6.0 mg/L and 75% saturation is generally considered unsuitable for many forms of aquatic life. Additionally, release of phosphorus (which promotes algal and plant growth) from bottom sediments can often be enhanced under anoxic (no oxygen) or very low oxygen (<1.0 mg/L) conditions. Temperature and dissolved oxygen are typically measured within the water column to determine the extent of lake stratification. Dissolved oxygen and temperature profiles for the dry weather sampling dates are presented in Table 4 and profiles are depicted graphically in Figures 6 and 7.

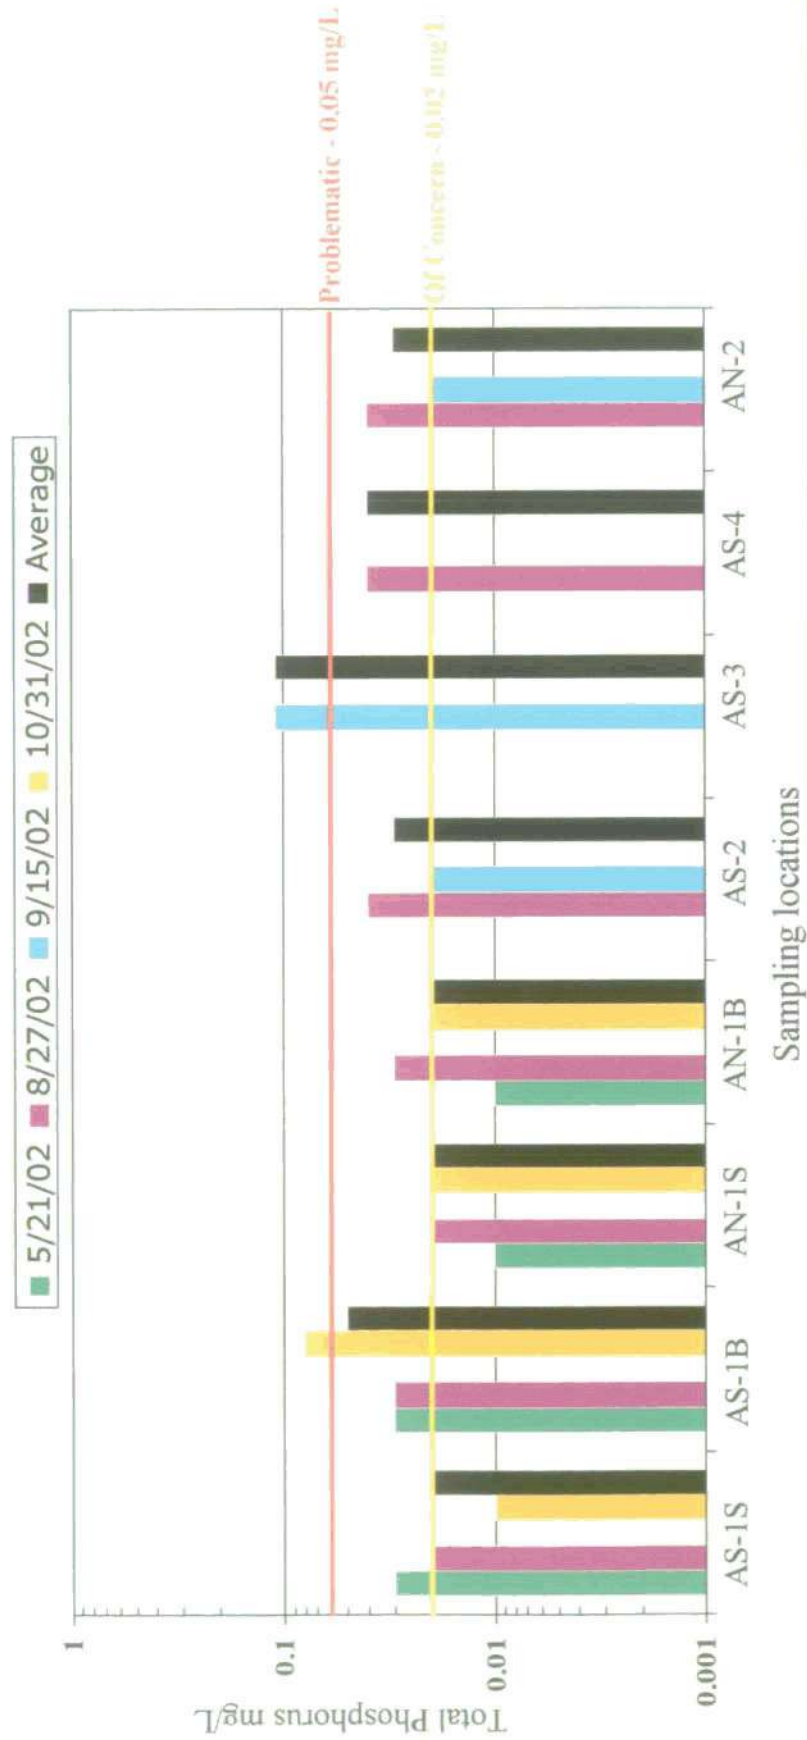
Figure 16. Average Total Phosphorus (mg/L) Levels at Ashmere Lake, 2002.

Total phosphorus values measured at the in-lake stations are relatively low, averaging 0.035 mg/L in the south basin and 0.020 mg/L in the north basin. These data suggest that only moderate amounts of phosphorus are available within the water column to fuel algal and plant growths (Table 5). In addition, the presence of a well-developed thermocline, particularly in the deeper south basin during the peak growing period, will also mitigate the effect of the extremely elevated phosphorus values (0.80 mg/L) observed at the bottom of the south basin during the August sampling event.

Slightly elevated average total phosphorus values of 0.03, 0.03 and 0.04 mg/L were also observed at monitoring stations AS-2, AN-2 and AS-4, respectively (Table 5). AS-2 and AN-2 are stations located on the major tributaries feeding the lake and indicate that the lake is receiving a substantial portion of its nutrients from these tributaries, particularly during dry weather periods.

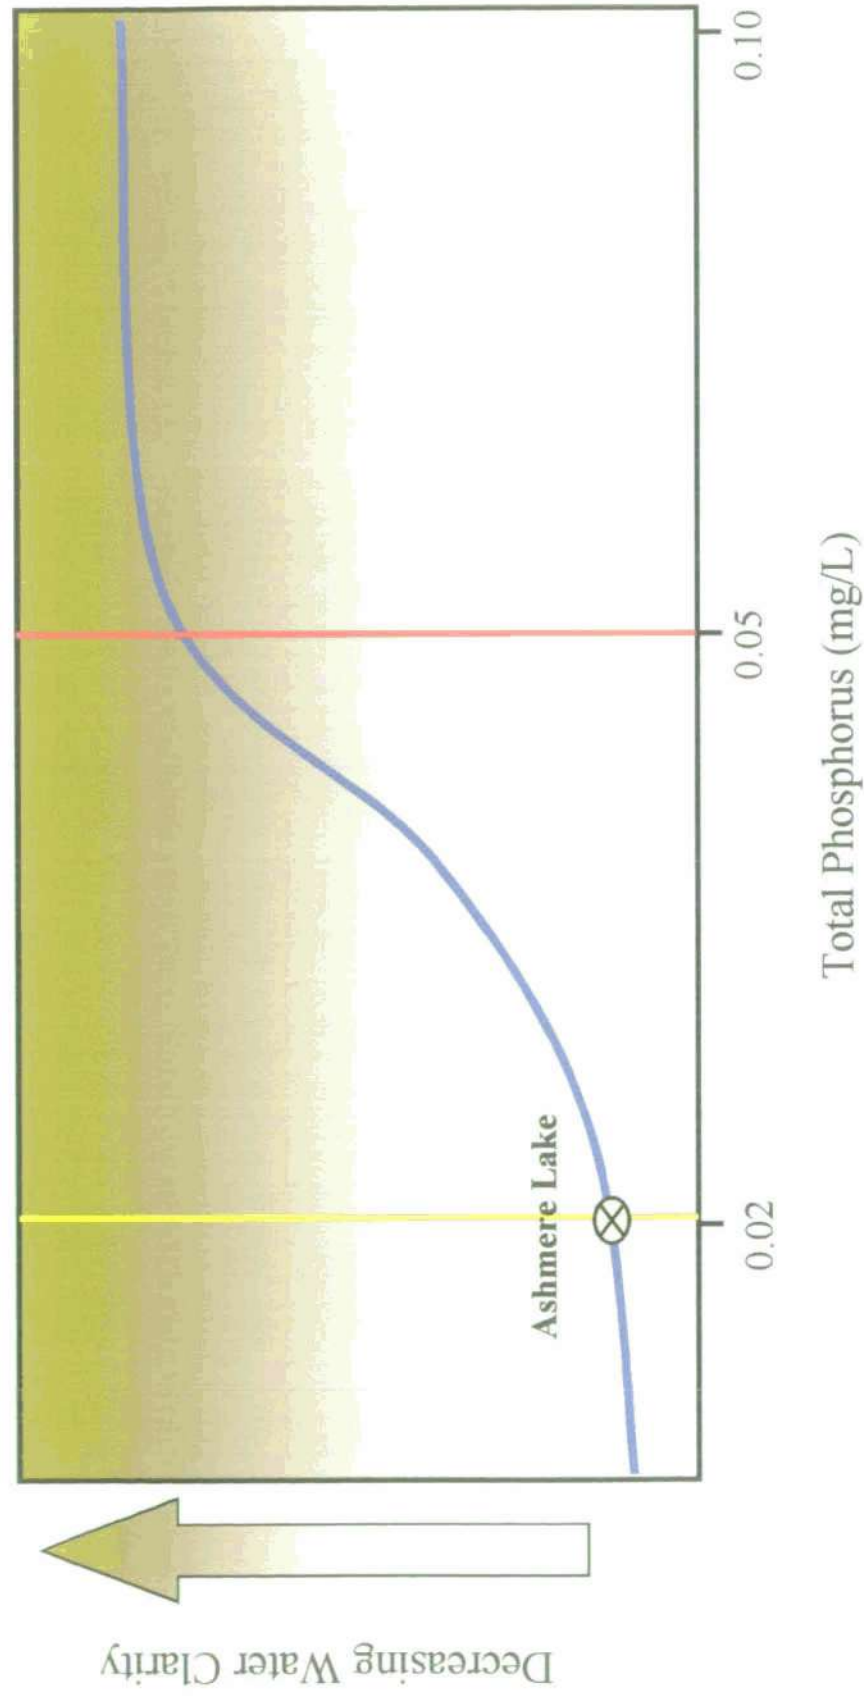
Figure 17. Relationship between Total Phosphorus and Water Clarity, Ashmere Lake.
Average of in-lake surface sampling locations (AS-1S & AN-1S).
